## RAILROAD CLIENT—DAVENPORT, IOWA

### ACCIDENTAL DIESEL FUEL RELEASE INITIAL RESPONSE/REMEDIATION

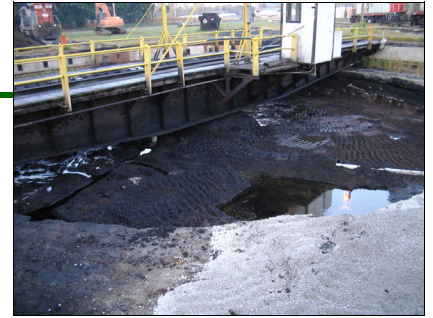
**The Challenge:** A locomotive engine holding an estimated 3600 to 4000 gallons of diesel fuel accidentally rolled into the turntable pit within its repair facility. The impact caused its fuel tank to rupture, leaking fuel into the holding pit which is part of the facility's Oil Water Separator System. Since the pit had a soil bottom with a high water table, there was concern of soil and water contamination if the crew could not recover the fuel quickly enough.

**Containment:** The free-floating diesel product was immediately pumped off the water into a used oil storage tank to be refined and recycled. Some product that had too much water or too much dirt in it was disposed of through standard haz-mat protocol.

**Site Remediation:** Soil at the bottom of the pit was excavated, stockpiled, tested, then hauled to the Waste Commission for proper disposal and Land Application. The bottom of the pit has been covered with concrete to help control any future ground contamination problems.

**Preventative Action:** Pinnacle staff were instrumental in assisting the client with improving their Pollution Prevention and Control procedures so to prevent this type of event from occurring again in the future. Better control devices were installed on the Oil Water Separator System to help prevent any material that has made it to the pit from leaving the pit and going to the Oil Water Separator and then on to the City water system.
